Docket No. 217 – Development and Management Plan Inspection

Northeast Utilities Service Company Certificate of Environmental Compatibility and Public Need for the construction of a 345-kV electric transmission line and reconstruction of an existing 115-kV electric transmission line between Connecticut Light and Power Company's Plumtree Substation in Bethel, through the towns of Redding, Weston, and Wilton, and to the Norwalk Substation in Norwalk, Connecticut.

Date: September 22, 2006

Location: 345kV Underground Route

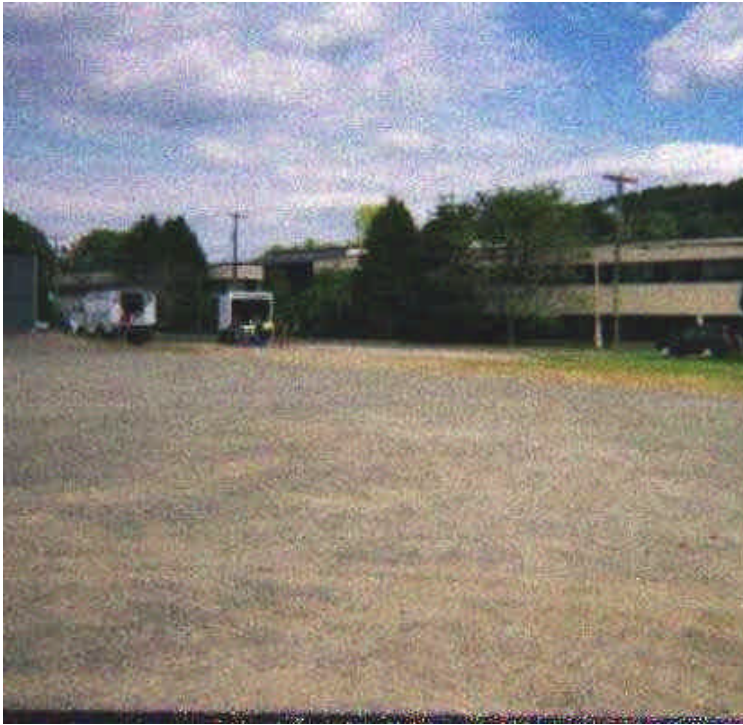
| Areas of Inspection | Observation | Recommended Action | Corrective Action |
|---|---|--|---|
| | - A large bare soil area remains near the Wilton HS tennis courts. Previous attempts had been made to restore the area but were unsuccessful. 8/30-9/22/06 | - Loam, seed and mulch this area. Fall seeding should generally be completed by Oct 15. 8/30-9/22/06 | - Needs attention when feasible. |

345kV: Photo on the left shows the remaining bare area near the Wilton HS tennis courts that will need restoration prior to the end of the growing season. Photo on the right shows the School Rd site where a parking lot is under construction for DOT work. This is unrelated to the 345kV project. 9/20/06

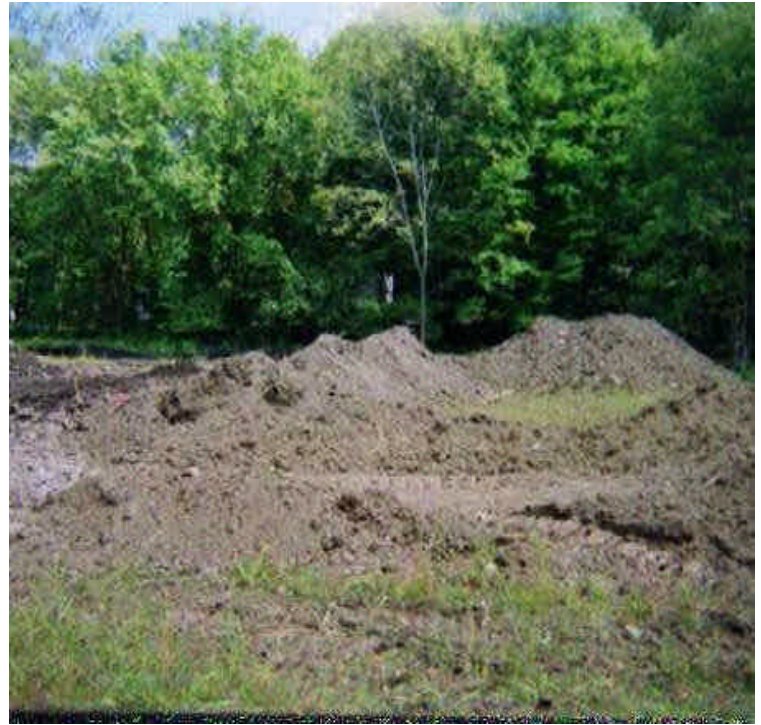
| Areas of Inspection | Observation | Recommended Action | Corrective Action |
|---|---|--|---|
| Erosion and Sediment (E&S) Controls Route 7 | areas along the perimeter wetlands remain in good shape. However, a parking lot is currently under construction in the old HDD yard for an unrelated DOT project in the area. 9/22/06 | erosion controls here will now be the responsibility of the current, unrelated project. 9/22/06 | project left the area stabilized. It is now under different jurisdiction. |

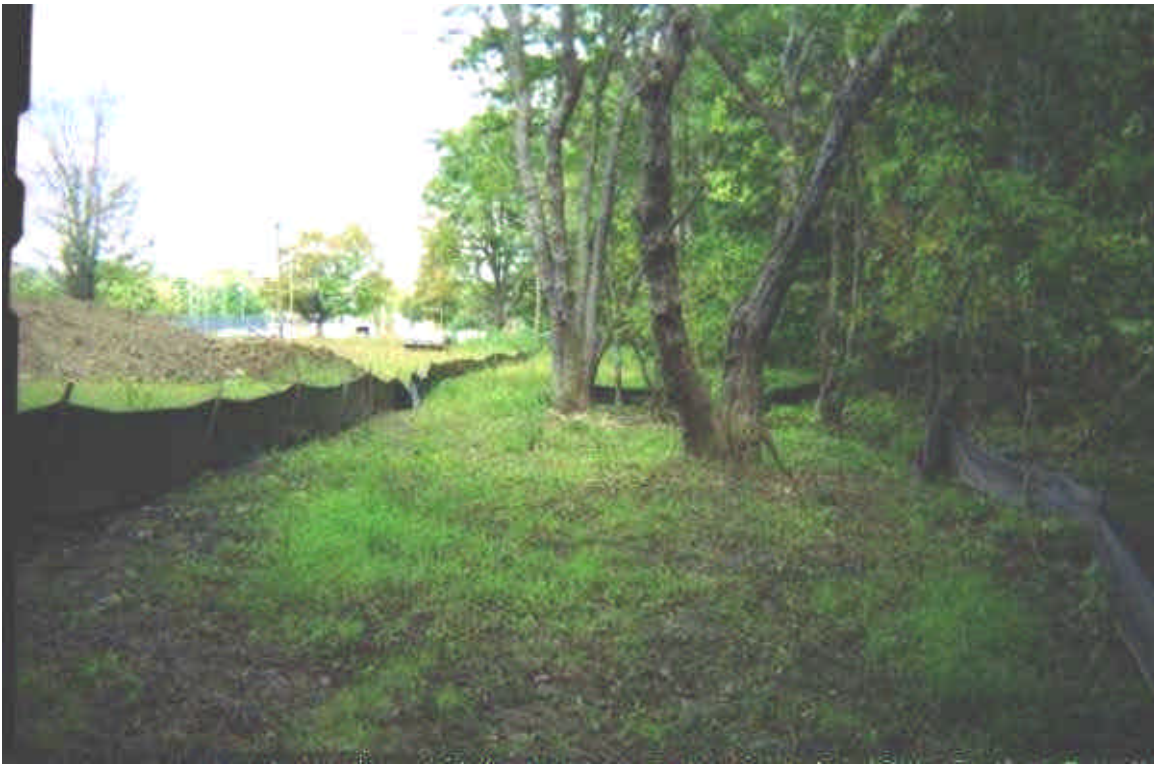
| Areas of Inspection | Observation | Recommended Action | Corrective Action |
|--|--|--|--|
| Adjacent Wetlands and Waterways | <p>- Vegetation was returning to wetland areas around the HDD site. Activities for an unrelated project are disturbing the adjacent area. 9/22/06</p> | <p>-The controls and status of the wetland will be the responsibility of the current project. The area was stable following the completion of the 345KV work 9/22/06</p> | <p>- No longer under this project's jurisdiction</p> |

Photo shows the wetland area to the east of the HDD continuing to revegetate. The adjacent yard is currently under construction for an unrelated project. It will be the responsibility of that project to keep erosion controls secure in the future. 9/20/06

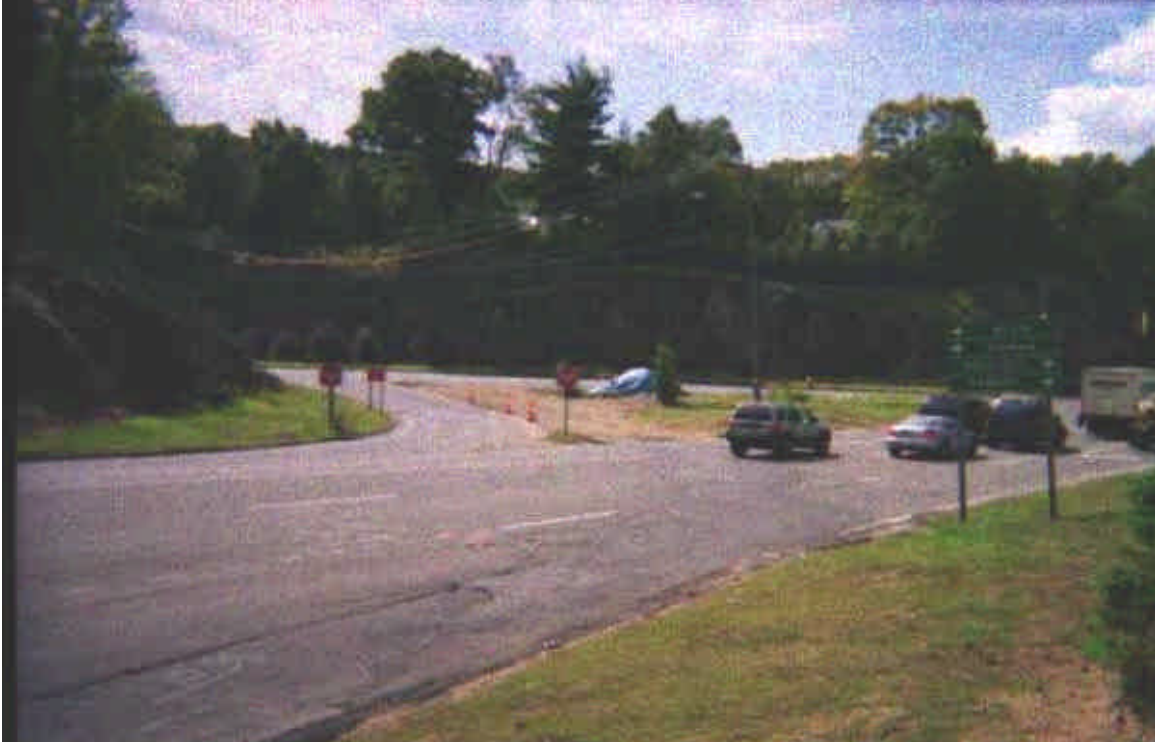
| Areas of Inspection | Observation | Recommended Action | Corrective Action |
|---|---|--|---|
| | - Catch basins near the Rt. 107 & 7 intersection do not have filters/ controls in place. Some disturbed soil is present although portions have been restored. 7/12-9/22/06 | - Install controls in the catch basins or finalize restoration of the island when access is complete. 4/6-9/22/06 | - Needs attention when feasible Portions were restored. |

Photo shows the Rt 107/7 intersection. Some areas have been restored and stabilized but final restoration is still required. 9/20/06

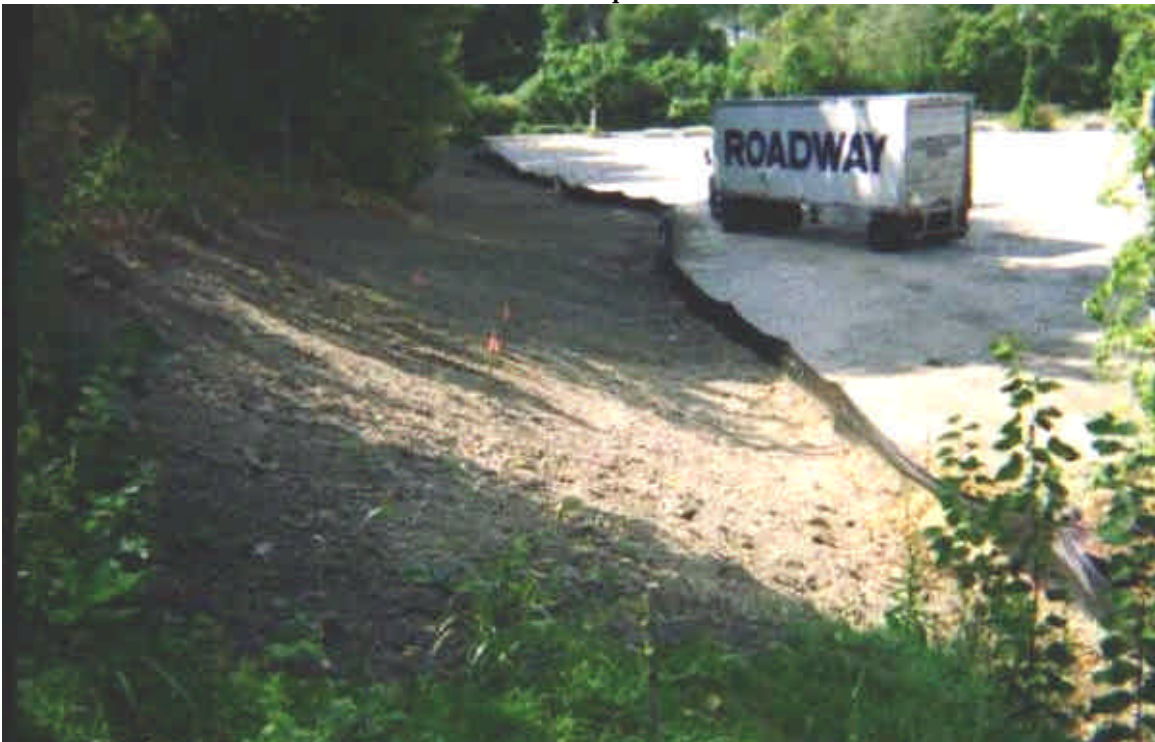
| Areas of Inspection | Observation | Recommended Action | Corrective Action |
|---|---|--|---|
| | - At the Georgetown HDD site (Gilbert & Bennett lot), the slope where the trenching had occurred was graded but did not appear to | - Seeding and mulching needs to occur. 8/9-9/22/06 Silt fence is now in place at the base of slope near | - Needs to be seeded. |

Photo shows a view of the silt fence installed at the Gilbert & Bennett lot. Seed and mulch are still needed here along the slope. 9/20/06
